Natural and Anthropogenic Impacts on Khanzad-Banaman Castle, a Geological-Cultural Heritage in Erbil-KR/ Iraq

Abstract: This study highlights the relevant categories of heritage and proposes strategies for prioritizing the protection of geological and cultural heritage, focusing on the importance of geoconservation and geotourism as tools for preserving geoheritage in a Castle, which is under increasing threat from climate change and anthropogenic impacts. It also assesses unique geomorphological landforms and cultural heritage sites affected by climate change and anthropogenic impacts. The case study focuses on Khanzad–Banaman Castle, a geological-cultural heritage site built in the 16th century and located atop a geological ridge of aesthetic value. The ridge consists of sandstone and claystone belonging to the Miocene Injana Formation. Engineering, geological, and anthropogenic surveys were conducted. The area is situated on the southwestern limb of the Permian anticline, and the rock slopes are affected by landslides, including rockfalls, toppling, wedge failure, and creep. These instabilities result primarily from discontinuities within the rock beds. Anthropogenic activities

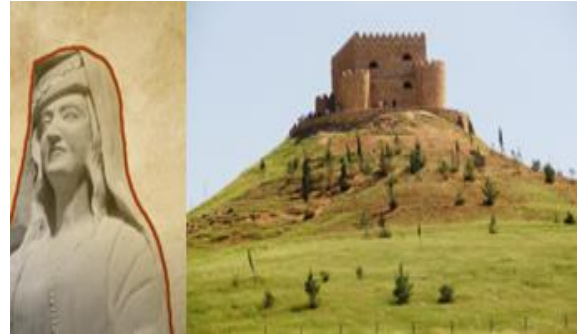
Fig. 2 Left - The statue of Khanzad, the princess of the Soran Emirate. Right - The cultural heritage of Khanzad-Banaman Castle (Zhyan Media, 2018).

It was used as a military base. The castle's name relates to Khanzad, which is the name of the "Kurdish Warrior Queen," who is commemorated and referenced in various Kurdish songs and poems. She ruled the Soran Emirate after her brother, King Mohammed, died after being poisoned. Khanzad-Banaman castle is a military fortress located in the north of Erbil city. Mir Muhammed built it in the late 1340 AH- 1824 AD (Ghafour, 2021). The castle is rectangular in shape and consists of two floors made from large stones and plaster (Fig. 2).

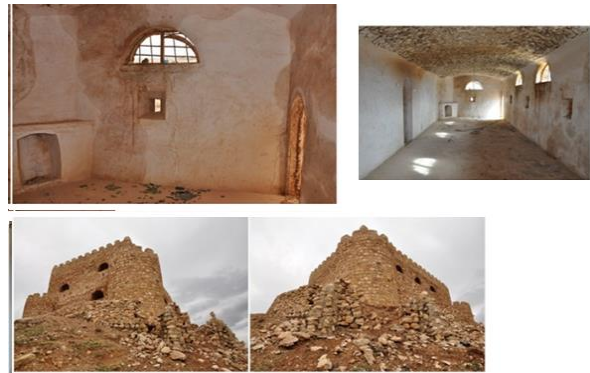
Fig. 3 Interior and exterior of Khanzad-Banaman castle before the Kurdistan Regional Government reconstruction. (Zhyan Media, 2018).

Khanzad-Banaman Castle is 40 meters high, and it has four round-shaped towers with many windows. The area of the castle is 15.5 meters long and 10.5 meters wide. Although the Kurdistan Regional Government reconstructed it in 2005, unfortunately, the castle suffers from neglect and a lack of management to protect it from landslides and loss of its cultural value, and to preserve the cultural heritage and the safety of tourists. (Fig. 3). The conservation of CNH is a way of

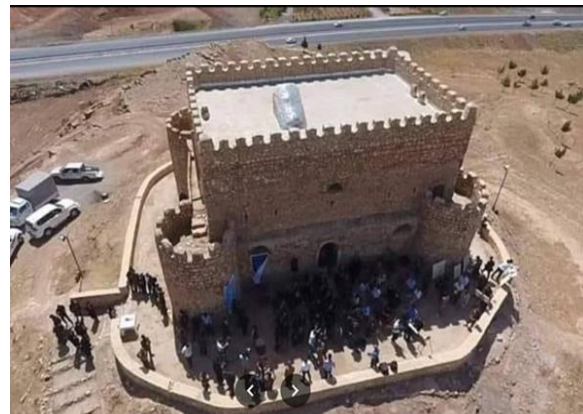
Bastura Valley is the major valley in the south of the geoheritage hill with a subsequence stream type. The limb slopes show various types of ridge including cuesta and hogback ridges. The geological heritage is located on a hogback ridge, which created a unique tourist attraction with an elevation of 840 m above sea level. The topography of the area is a hill in the southwestern limb of Permian anticline. Its height above the ground surface is about 40 m. (Fig. 6).

Fig. 6 Top of the hill, which is a unique tourist attraction, photo taken in June 2021.

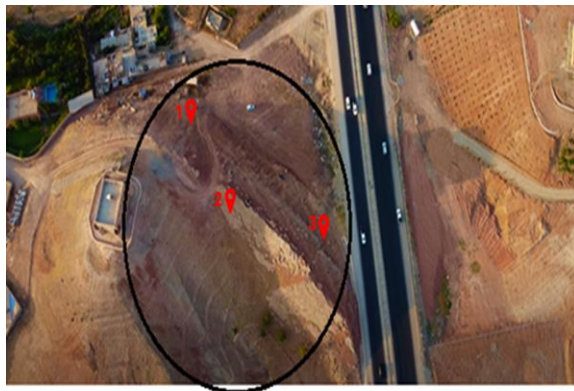
Natural processes and human-induced geomorphological activities affect the stability of rocky slopes at the three stations (Fig. 7).

Fig. 7 Location of the stations showing the most affected area.

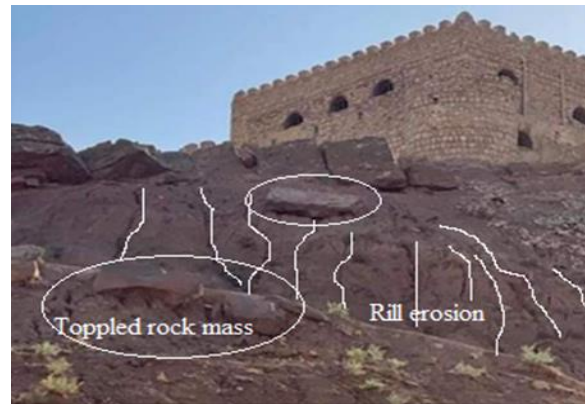
Evidence of rockfall is pointed out in Figure 8). From the Kinematic analysis the following failures occurred are concluded mass-wasting type creep of claystone with several rill erosion signals on the slope surface with the direct and flexural toppling of sandstone rocks and planar and wedge sliding failure (Fig. 9), which resulted from the weathering and erosion processes of the claystone below sandstone beds causing the detached blocks of sandstone bed topple down on the slope surface.

Fig. 8 Southwest slope view of station 1.

Station No. 1: This station is located at the start of an irregular pathway made on the hill foot consisting of red claystone of the Injana Formation with a thickness

of 28m, overlaid by a sandstone bed, dipping $40^\circ/220$. The attitude of the slope is $70^\circ/130$ with a width of 7m, height variable 4-8 m, and type parallel and discordant. The discontinuities are $90^\circ/130$, $80^\circ/215$ and $80^\circ/240$.

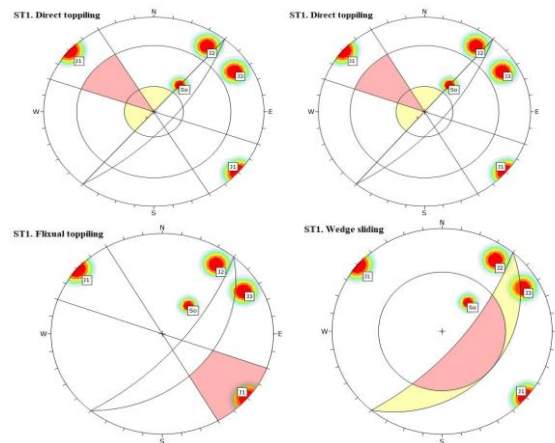
Fig. 9 Kinematic analysis of station 1.

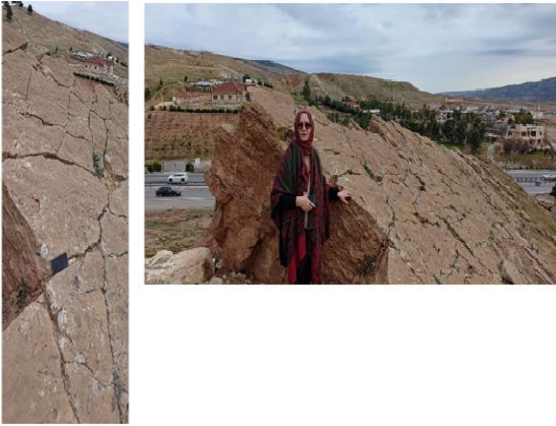
about 6 m. The slope width is about 10 m, height 4m, with an attitude of $40^{\circ}/200$. The attitude of the sandstone bed is $36^{\circ}/217$. The slope type is a parallel slope and concordant. The sandstone bed is densely fractured with three sets of joints $80^{\circ}/130$, $90^{\circ}/215$, and $90^{\circ}/240$ (Fig. 10). Using the stereo projection (Kinematic Analysis) concluded that there are direct and flexural toppling of sandstone rocks and planar and wedge sliding failure (Fig. 11).

Fig. 10 Station 2 shows the systematic and nonsystematic joints (E view).

Station No. 2: The slope consists of a sandstone bed of Injana Formation with a 25-50 cm thickness and red claystone beds laid under the sandstone bed of

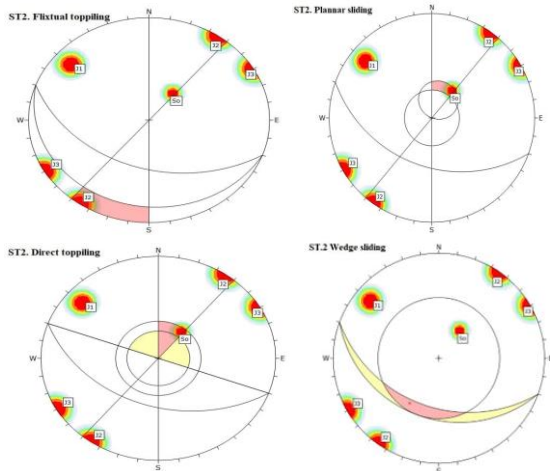
Fig. 11 The Kinematic analysis of station 2.

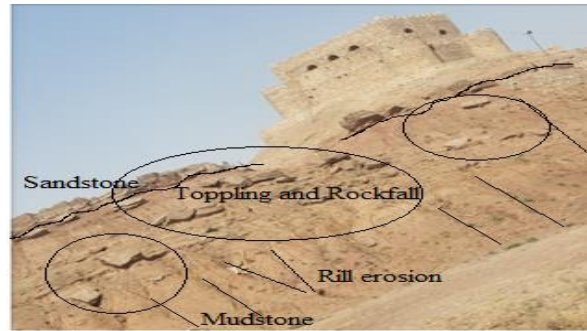
Station No.3: This station consists of interlayers of sandstone beds and mudstone, dipping $35^{\circ}/195$. The slope is variable in the upper part, is 30° to a vertical rock slope direction 104 in the lower part of the slope, 17 m high and 12 m wide. The sandstone layer is fractured by discontinuities with three sets of joints; the first attitude is $80^{\circ}/128$, the second is $90^{\circ}/238$, and the third is $90^{\circ}/214$. The resulting collapse is a rockfall due to the presence of discontinuities. The cohesion

between discontinuities is zero, allowing rock masses to fall down the slope under their own weight. The expected collapse are toppling due to the presence of clay layers that offer weak resistance to the rock masses above them, as well as the presence of fractures surrounding the rock masses, which leads to toppling of the sandstone bed and creep of claystone from the slope surface to the ground surface, where the main road is, the Kinematic analysis shows the following failures: Plane sliding Wedge sliding Flexural toppling direct toppling. (Figs. 12 and 13).

Fig. 12 Rock cliff holding on the top the historical castle of cultural heritage - Station 3 (NW view).

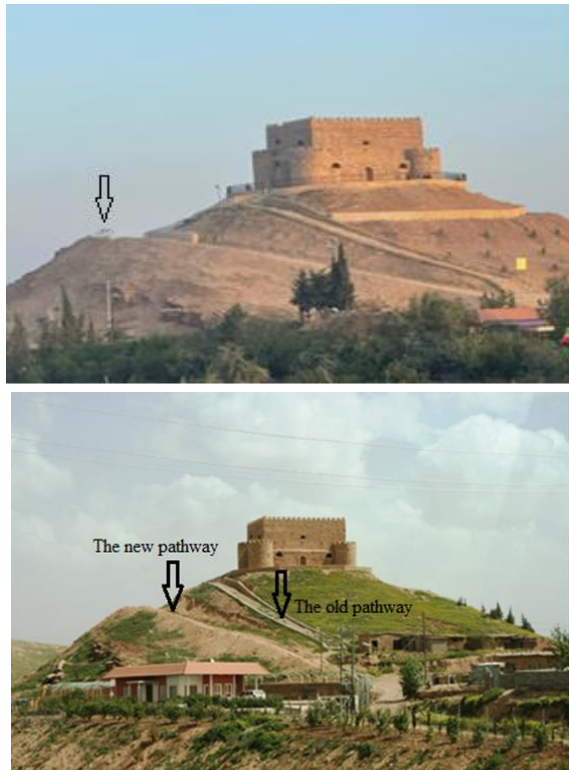
The anthropogenic impacts on the cultural heritage area are studied by surveying the pathways around the castle and noticing that there are two pathways to the top of the hill to the castle gate, the first (the stairway) pathway. The second is that the new path is nearly parallel to the first, with a partially paved stairway on the top and not paved from the ground, wider than the old path, and allows vehicles to drive up the hill, which is not necessary and creates a large surface of erosion exposure (Fig. 14).

Fig. 14 Left- the new pathway is wide, showing the vehicle on top. Right- the two pathways are visible.

Threats to protected and other conservation areas can range from global threats relating to climate change, regional-scale threats such as habitat fragmentation, and localized problems including poaching, excessive visitor impacts and waste disposal. Developing and implementing response strategies to these threats is an essential part of protected area management (UNESCO, 2012). This study reveals that the study area is suffering from the threatening impacts of climatic, geological, and anthropogenic factors. To avoid damage to cultural heritage and the hazards of landslides, which can endanger the safety of tourists, the most effective factor is minimizing the pathways surrounding the cultural heritage by retaining the old pathway while closing the unnecessary new pathway.

The author recommends that the original path should be properly maintained, as this is preferable to creating a second, unnecessary path, which has increased slope instability. As urban development and infrastructure expansion, particularly the construction of roads and tunnel continue, it is essential to carefully consider environmental protection and nature conservation, even when such structures are designed to blend with the natural landscape. Several methods can be employed to improve slope stability, including grouting to fill voids and strengthen rock surfaces, the use of materials such as steel mesh or fibre-reinforced polymers to reinforce the rock mass, and the construction of retaining walls to provide additional support.

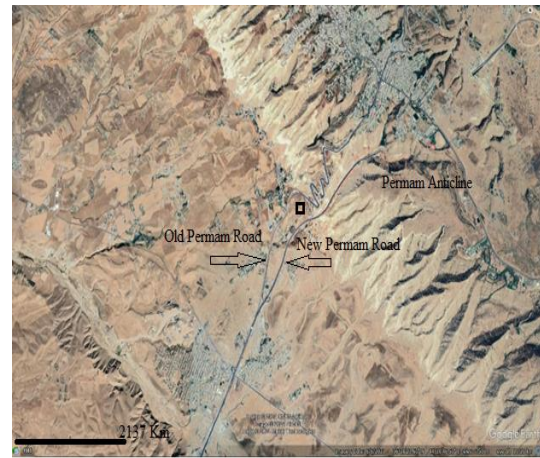
From the author's observation, the main road was to the west of the castle hill until the late nineties; a new road was constructed to the east of Khanzad-Banaman castle hill. Cultural heritage can play a role in

sustainable development. Various points highlight the role of cultural heritage (both tangible and intangible) in urban sustainable development. Moreover, some international organizations, such as UNESCO and ICOMOS (International Council on Monuments and Sites), highlight the key role of culture in achieving sustainable development (Nocca, 2017; Hosagrahar et al., 2016; Potts, 2016; Augustin, 2007). Transportation systems, such as highways, are vulnerable to rockfall wherever they cut across or skirt along mountains, plateaus, ridges and similar topographic features (Bunce et al., 1997; Hunger et al., 1999). Road construction has led to changes in the features of the surrounding lands along the road. The construction of the new road on the eastern side of Banaman-Khanzad castle has led to changes in the area and shape of the hill on which the castle is built (Fig.15). According to the researcher's observations, the area of the hill was larger and circular before the 1990s.

Fig. 15 Google image of the study area shows the two main roads on both sides of the cultural heritage hill.

The construction of the new road has affected the area and shape of the hill, as well as the stability of the hill and the castle. In addition to another human factor that negatively affected the stability of the hill by building a stair path from the bottom to the top of the hill to reach the castle, opening a new second stair path parallel to the old path led to the presence of new unstable slopes that led to more erosion and collapses of the type of clay rock creep, cracking and rockfall of sandstone and clay beds. Sufficiently maintaining the first old path and treating it was better than cutting a second unnecessary path, which increased the instability on the slopes (Fig. 16).

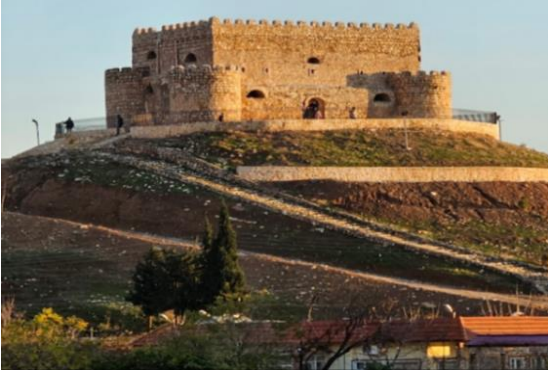
Fig. 16 The view shows a new wide road being cut, exposing the rocky slopes and the old stairway to gradual collapse.
