## Use of Underground Mining Activities in Earthquake Search and Rescue Works

**Abstract:** Although the mining sector has the task of providing raw materials directly or indirectly to industrial establishments, it unfortunately contains great dangers and risks for its employees in terms of occupational health and safety. Especially in mining enterprises operating underground, roof collapse, sudden gas discharge, flooding, gas explosions etc. negativities that occur during production cause great material and moral destruction. In such big problems, well-trained rescue teams of mines play an important role in saving the lives of many miners. Earthquake disasters affecting 11 provinces in Turkey caused great destruction, many people died in building debris and collapses, and buildings and industrial facilities were severely damaged on Feb. 6 2023. In the search and rescue works that started after the earthquake, the outstanding efforts of the underground mine workers in the field and the methods they used in these studies attracted the attention of the public. In this study, evaluations were made by giving some underground rescue methods used in search and rescue activities in the A

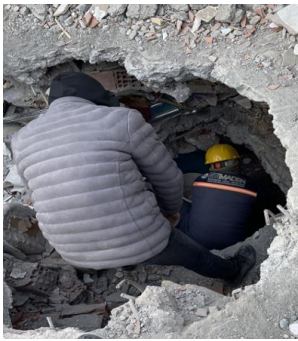
In addition to other domestic and foreign institutions and organizations, the personnel of public and private sector mining companies (Turkish Hardcoal Corporation, Turkish Coal Board, Eti Mine Directorate, Imbat Mining, Coal Enterprises Inc., etc.) participated in the search and rescue efforts after the earthquake. After the live reports from the collapsed buildings, the underground mine workers and other search and rescue teams in the field went to the ruined buildings and the rescue efforts began after the location of the wreckage was determined with the help of thermal camera, sound listening devices and search and rescue dogs. Afterwards, it was tried to reach the people under the debris by making connections in the form of shafts from the appropriate floors of the buildings with the help of equipment such as electric drills from the closest distance to the wreckage (such as the sublevel connection work in mining) (Fig. 5).

Fig. 5 Shaft-shaped search and rescue operation.

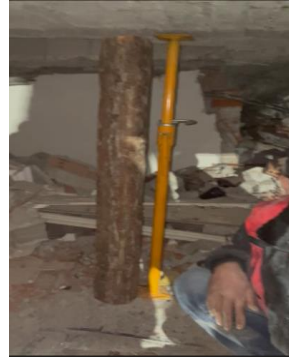
The fact that the buildings where rescue activities will be carried out were severely affected by the earthquake and the removal of injured people by entering these buildings was noted as the most important difficulty encountered during these works. For this reason, the safety of the collapsed buildings was ensured first. The collapsed floors were supported by wooden supports against collapse. In addition, the works continued by making reinforcements with small steel supporting posts (Figure 6).

Fig. 6 Collapse control work by the use steel and wooden supports

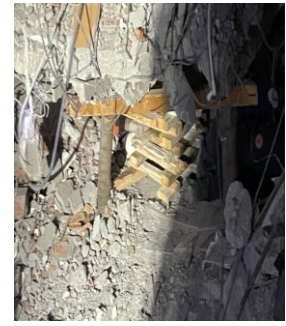
In order to carry out salvage works in buildings that were heavily damaged by the devastating effect of the earthquake, wooden supporting elements reinforced with wood cribs, which are widely used in underground mining operations, made progress by providing safety in collapsed buildings and many people were rescued from the debris (Fig. 8).

Fig. 8 Wood crib reinforced supporting work.
