Climate Change Impact and Frequency of Cyclone Surge in Bangladesh Coast: Proper Plan to Address Sustainably

Md. Bazlar Rashid^{a*}, Md. Rubel Sheik^a, A.J.M. Emdadul Haque^a, Mohammad Abdul Aziz Patwary^a

^aGeological Survey of Bangladesh (GSB), Dhaka, Bangladesh

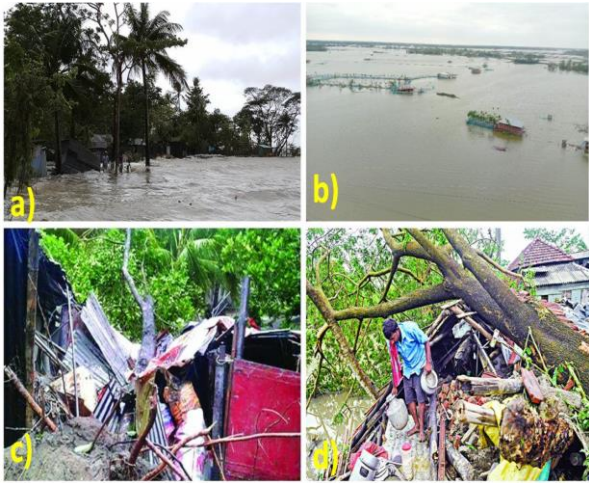
Fig. 3 a) Vast area was inundated due to cyclone Amphan at Nolchira union, Hatiya, Noakhali (Anon, 2020a); b) Area was inundated due to damage of embankments of the Kabodak and Shakhria rivers by cyclone Amphan at Koyra, Khulna, Noakhali (Anon, 2020b); c) The trees were uprooted and fallen over settlement houses by cyclone Mora (Anon, 2017b); d) The trees were uprooted and fallen over settlement houses by cyclone Amphan (Anon, 2020c)

Historically, cyclones have killed many people of the coast of Bangladesh at different times (Figs. 2, 3). Bangladesh made huge investment in cyclone preparedness, community-based early warning systems, hydro met initiatives, and adaptive delta management, combined with sound structural interventions (Kazi 2020; Sammonds et al., 2021). Therefore, the death toll has dropped significantly in recent times but the loss of properties is still enormous (Figs. 3, 4). For example, cyclone Sidr (Anon, 2008) hit the coast of Bangladesh on 15 November 2007 with winds up to 240 km/hr. It was category-4 storm and tidal waves up to five meters high and surging up to 6 meters in some areas. High winds and floods caused damage to housing, bridges, roads, and other infrastructures. Communication and electricity infrastructures were destroyed, and waterways and roads became unusable. About 2.3 million households were affected. The total economic loss was US\$ 1.7 billion, and 3,406 people died, with 1,001 missing and more than 55,000 physically injured. The cyclone Aila hit the country on May 25, 2009 (Anon, 2009). It damaged over 500,000 houses, about 1,000 km of embankments, some 7,000 km roads and crops on more than 123,000 hectares, livestock and other properties in eight districts in coastal areas. The economic loss was about US\$ 269.28 million and 179 people died. The cyclone Mahasen (Anon, 2013) hit the country on May 16, 2013. Nearly 49,000 houses were completely and 45,000 houses partially destroyed, and over 1.2 million people were affected and 13 people died. The economic loss was about US\$ 35.3 million.

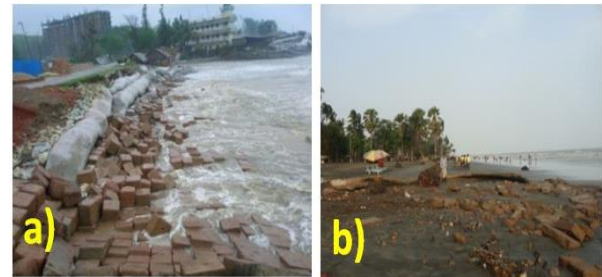
Fig. 5a) Severe erosion occurs at Kalatoli beach, Cox's Bazar due to cyclone Mahasen; b) Severe erosion occurs at Kuakata beach, Kalapara, Patuakhali due to cyclone Mahasen.

Erosion is another risk in the coastal part of the country. Islam et al. (2011) conducted study on the issue of changing the form of the coast of Bangladesh and concluded that about 1121 km² of land was eroded from 1972 to 2010. The erosion is taking place mainly in the Sundarbans, Cox's Bazar - Teknaf and Kuakata coast, Kutubdia, Sandwip, Hatiya and Bhola Islands, and it increases further during the occurrence of cyclones (Fig. 5a,b).

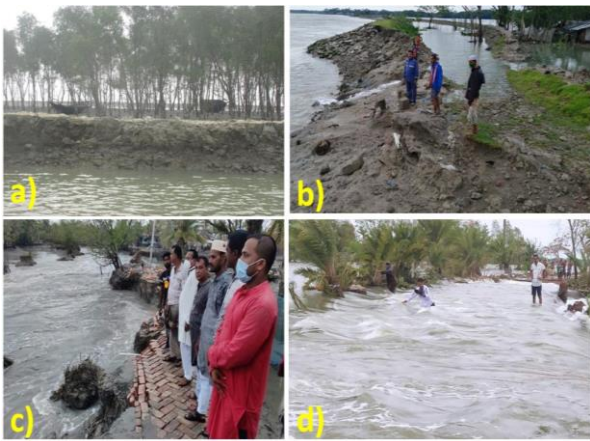
Fig. 6 a) Weak embankment at the right bank of the Kabodak river at Pratapnagar, Asasuni, Satkhira; b) The collapsed embankment of 35/1 polder of Water Development Board (WDB) in Sharankhola upazila of Bagerhat by Cyclone Amphan (Anon, 2020d); c) A broken road submerged in water due to cyclone Amphan (Islam, 2020a); d) Saline water overtopped the river banks due to cyclone Amphan (Islam, 2020b).

Moreover, recently, the frequent cyclone storms and related tidal surge further delicate the situation. Because, in most parts of the coast, the embankments along the rivers are very weak (Fig. 6a, b) and it can not protect the flood water. Furthermore, many embankments and polders are damaged or destroyed during cyclone surge and tidal saline water inundated the areas (Fig. 6b, c). In some cases tidal water overtopped the banks of the rivers and inundated the areas, and thereby long time water logging (Fig. 6d), as the water can not easily pass through the abandoned or congested tidal channels. In many cases the river bed is higher than the height of nearby plain lands due to channel sedimentation and at the same time lack of sedimentation in the surrounding plains. The Bangladesh Soil Resources Development Institute has shown that during 1973 to 2000, about 0.170 million hectares (20.4 percent) of coastal land was affected by salinity (SRDI, 2001). At present crops in different parts of the coastal area cannot give proper yield. Agriculture is the main sector of the economy of Bangladesh and more than thirty percent of the total cultivable land is in the coastal areas. Among the 2.85 million hectares of coastal and off-shore land, about 1.05 million hectares of arable land was affected by various levels of salinity (Asib, 2011). The whole coastal area is suffering from freshwater crisis due to salinity. Salinity is also found in deep tube well water in the area.

It is concluded that the embankment should be wide enough with sufficient height considering the tidal amplitude during cyclone surge. The embankment should be covered with vegetation to protect erosion. The appropriate slope must be maintained and also distances from the main channel need to be carefully maintained to protect it from surge. More cyclone
